Ms. Fran Pawlak, Executive Director
Dobson Ranch HOA
2719 South Reyes
Mesa, Arizona 85202

August 2023 Lake Report

August 2023 Report Narrative Summary

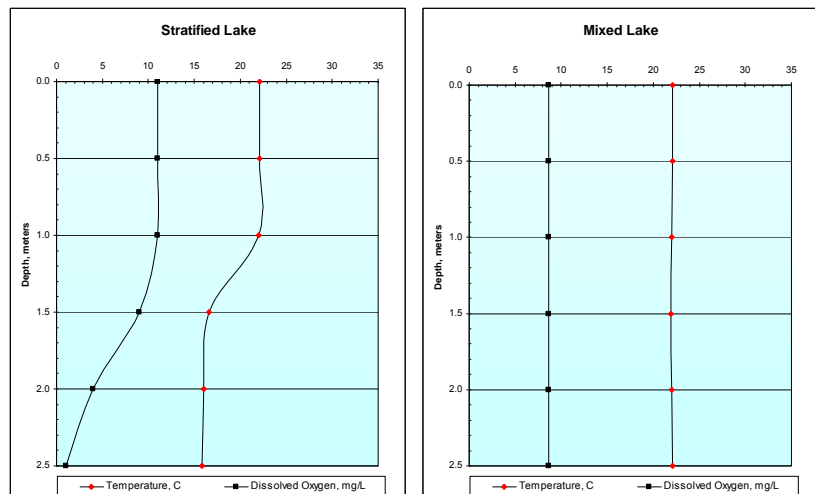
Density differences in water caused by temperature produce a physical barrier to the exchange of gases and nutrients between water layers. Typically warmer (less dense) water rests above deeper, cooler (more dense) water. Deep waters can become anoxic (oxygen poor) and cause the formation and release of

toxic gases as hydrogen sulfide and ammonia, and the release of plant nutrients as phosphates. A vertically mixed lake rarely suffers from such issues.

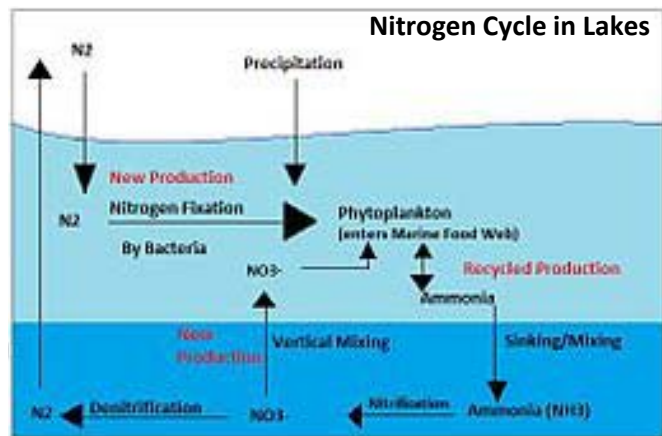
Algae are plants and require nitrogen and phosphorus for growth. In the desert southwest, large growths of planktonic algae typically form in the summer when total phosphorus concentrations are above 0.030 mg/L. Nitrogen values usually need to be at least 10 times that of phosphorus and in a soluble, usable (nitrate or ammonia) form to stimulate algae growth. Phosphorus and nitrogen cycles in the aquatic environment are illustrated below.
